**Flood Control Project Maintenance
Levee Inspections**

Fall 2018 Levee Maintenance Deficiency Summary Report

Sacramento River Basin

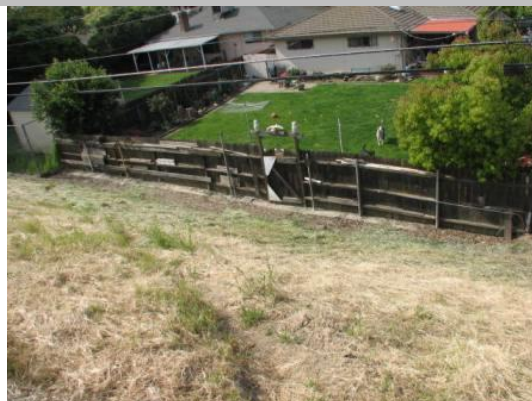
Photo 1 of 1 : FA_2018_NA0001_55_24_20180911_00024.jpg

LM Start	4.22	Rating **	U	Issue No.	24
LM End	4.22	Issue Type +	En	Location *	LS
Category	Earthen Levee			GPS Latitude/Longitude	
				Start	End
Item	Encroachments			38.583265 °	38.583265 °
				-121.442965 °	-121.442965 °
DWR ID	DWR_NA0001_04_s_2012_24				
Comment Code					
FE : Fence					
Inspector Comment					
Wooden privacy fence obstructs visibility. Retaining wall built into levee toe. 04/14/2011 retaining wall removed.

04/14/2011 Retaining wall has been removed. Wooden fence remains and is obstructing access and visibility.

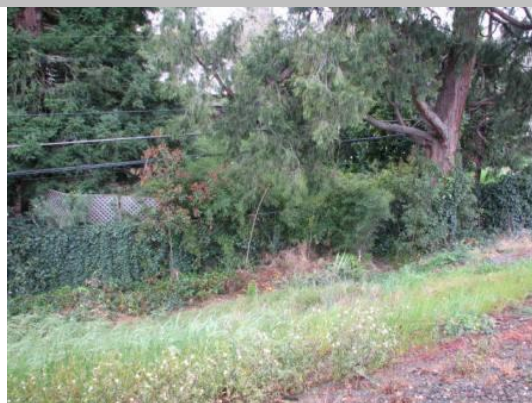
Photo 1 of 1 : FA_2018_NA0001_55_192_20180911_00164.jpg

LM Start	4.25	Rating **	U	Issue No.	192
LM End	4.25	Issue Type +	En	Location *	LS
Category	Earthen Levee			GPS Latitude/Longitude	
				Start	End
Item	Vegetation			38.583031 °	38.583031 °
				-121.442620 °	-121.442620 °
DWR ID	DWR_NA0001_04_s _ 2012_192				
Comment Code					
V6 : Landscaping					
Inspector Comment					
Ivy and vine growth on cyclone fence obstruct visibility. Steps and landscaping built up levee slope.

03/16/2012 Landscaping on fence obstructs visibility and access.

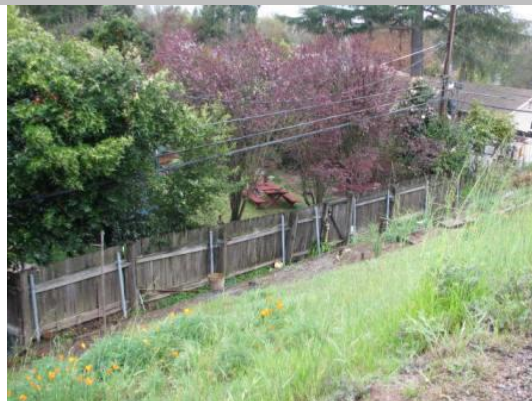
Photo 1 of 1 : FA_2018_NA0001_55_26_20180911_00025.jpg

LM Start	4.31	Rating **	U	Issue No.	26
LM End	4.31	Issue Type +	En	Location *	LS
Category	Earthen Levee		GPS Latitude/Longitude		
			Start	End	
Item	Encroachments		38.582479 °	38.582479 °	
			-121.441768 °	-121.441768 °	
DWR ID	DWR_NA0001_04_s_2012_26				
Comment Code					
FE : Fence					
Inspector Comment					
Wooden fence within 10-ft of the levee toe. Garden and ramp built on levee slope.

03/16/2012 Wood privacy fence completely obstructs access and visibility.

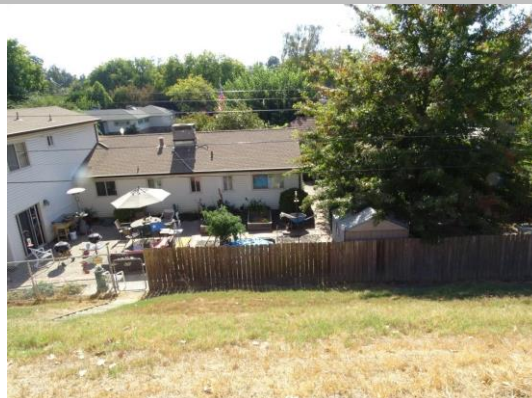
Photo 1 of 2 : FA_2018_NA0001_55_29_20181026_00285.jpg

LM Start	4.36	Rating **	M	Issue No.	29
LM End	4.36	Issue Type +	En	Location *	LS
Category	Earthen Levee			GPS Latitude/Longitude	
				Start	End
Item	Encroachments			38.582083 °	38.582083 °
				-121.440875 °	-121.440875 °
DWR ID	DWR_NA0001_04_s_2012_29				
Comment Code					
FE : Fence					
Inspector Comment					
Wooden fence located at the levee toe obstructs access and visibility. 04/14/2011

View of wooden fence at levee toe. Fall 2018

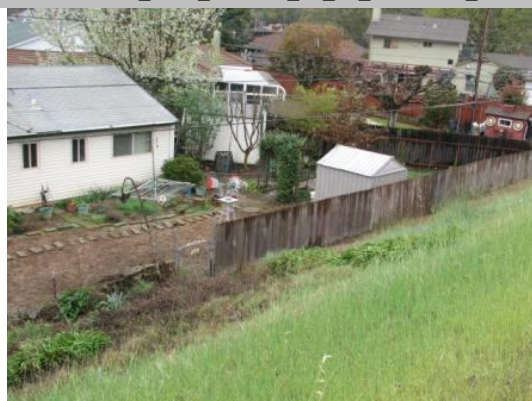
Photo 2 of 2 : FA_2018_NA0001_55_29_20180911_00028.jpg

03/16/2012 Flowering bush is dormant; landscaping on levee slope and wooden privacy fence.

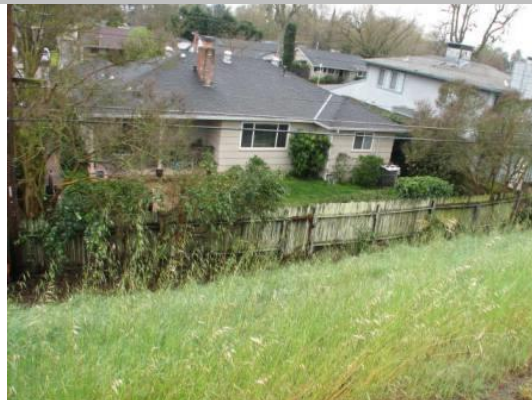
Photo 1 of 1 : FA_2018_NA0001_55_198_20180911_00168.jpg

LM Start	4.41	Rating **	U	Issue No.	198
LM End	4.41	Issue Type +	En	Location *	LS
Category	Earthen Levee			GPS Latitude/Longitude	
				Start	End
Item	Encroachments			38.581788 °	38.581788 °
				-121.440086 °	-121.440086 °
DWR ID	DWR_NA0001_04_s_2012_198				
Comment Code					
FE : Fence					
Inspector Comment					
Privacy fence and landscaping within 10-ft of the levee toe obstruct access and visibility.

03/16/2012 Wood privacy fence completely obstructs access and visibility.

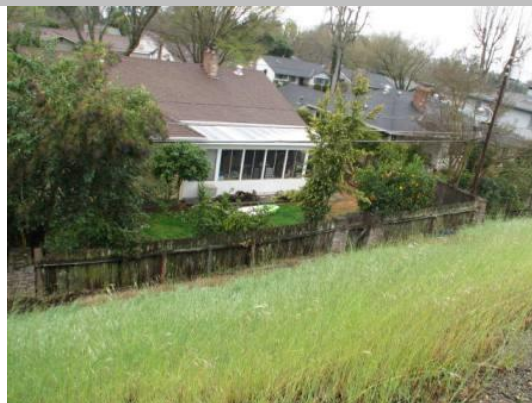
Photo 1 of 1 : FA_2018_NA0001_55_30_20180911_00029.jpg

LM Start	4.42	Rating **	U	Issue No.	30
LM End	4.42	Issue Type +	En	Location *	LS
Category	Earthen Levee			GPS Latitude/Longitude	
				Start	End
Item	Encroachments			38.581724 °	38.581724 °
				-121.439891 °	-121.439891 °
DWR ID	DWR_NA0001_04_s_2012_30				
Comment Code					
FE : Fence					
Inspector Comment					
Privacy fence and landscaping within 10-ft of the levee toe obstruct access and visibility.

03/16/2012 Wood privacy fence completely obstructs access and visibility.

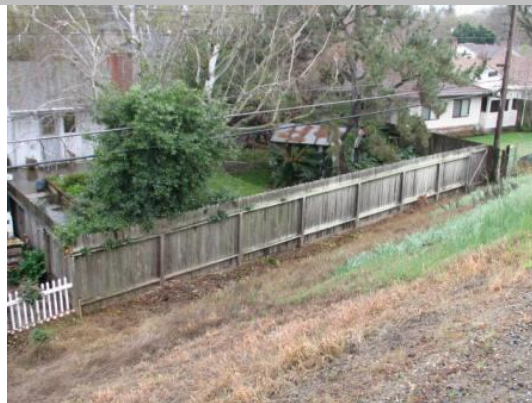
Photo 1 of 1 : FA_2018_NA0001_55_31_20180911_00030.jpg

LM Start	4.47	Rating **	U	Issue No.	31
LM End	4.47	Issue Type +	En	Location *	LS
Category	Earthen Levee			GPS Latitude/Longitude	
				Start	End
Item	Encroachments			38.581495 °	38.581495 °
				-121.439129 °	-121.439129 °
DWR ID	DWR_NA0001_04_s_2012_31				
Comment Code					
FE : Fence					
Inspector Comment					
Privacy fence within 10-ft of the levee toe obstructs access and visibility.

03/16/2012 Wood privacy fence completely obstructs access and visibility.

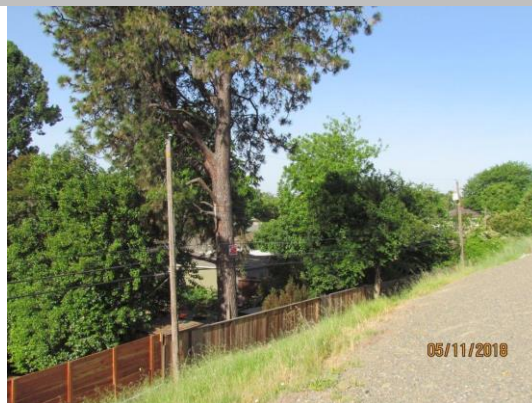
Photo 1 of 2 : FA_2018_NA0001_55_199_20180911_00169.jpg

LM Start	4.54	Rating **	U	Issue No.	199
LM End	4.54	Issue Type +	En	Location *	LS
Category	Earthen Levee			GPS Latitude/Longitude	
				Start	End
Item	Encroachments			38.581205 °	38.581205 °
				-121.437830 °	-121.437830 °
DWR ID	DWR_NA0001_04_s_2012_199				
Comment Code					
FE : Fence					
Inspector Comment					
New wood privacy fence completely obstructs access and visibility. Fruit tree also encroaches levee slope.

New wood privacy fence completely obstructs access and visibility, Spring 2018.

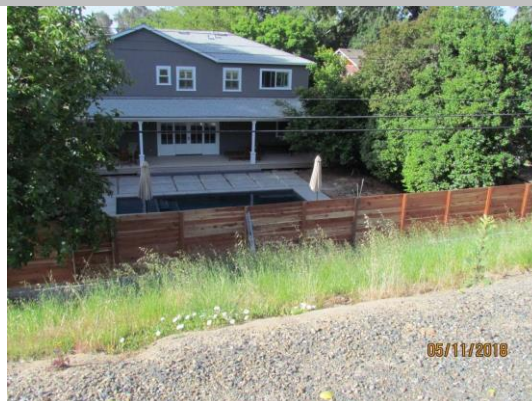
Photo 1 of 2 : FA_2018_NA0001_55_200_20180911_00171.jpg

LM Start	4.55	Rating **	U	Issue No.	200
LM End	4.55	Issue Type +	En	Location *	LS
Category	Earthen Levee			GPS Latitude/Longitude	
				Start	End
Item	Encroachments			38.581178°	38.581178°
				-121.437584°	-121.437584°
DWR ID	DWR_NA0001_04_s_2012_200				
Comment Code					
FE : Fence					
Inspector Comment					
New remodel, new pool, and new fence; the privacy fence completely obstructs access and visibility, Spring 2018.

View of the new remodel, new pool, and new fence; the privacy fence completely obstructs access and visibility, Spring 2018.

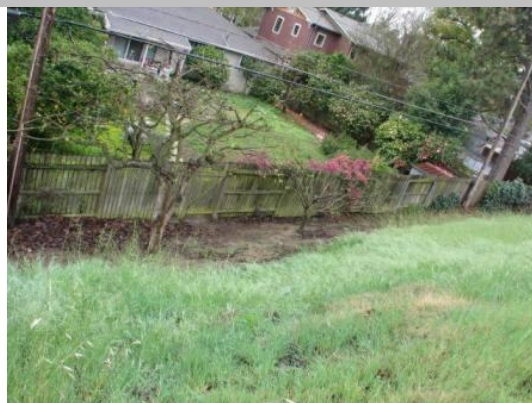
Photo 2 of 2 : FA_2018_NA0001_55_200_20180911_00172.jpg

03/16/2012 Wood privacy fence completely obstructs access and visibility.

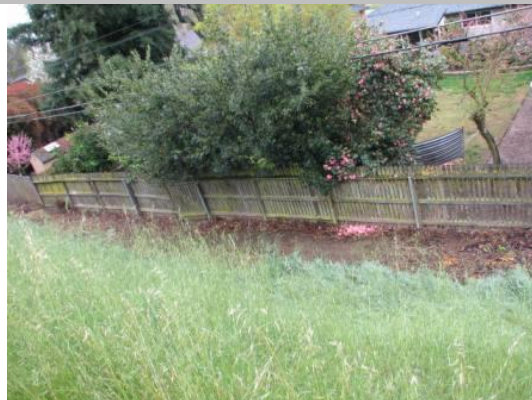
Photo 1 of 1 : FA_2018_NA0001_55_201_20180911_00173.jpg

LM Start	4.57	Rating **	U	Issue No.	201
LM End	4.57	Issue Type +	En	Location *	LS
Category	Earthen Levee			GPS Latitude/Longitude	
				Start	End
Item	Encroachments			38.581155°	38.581155°
				-121.437320°	-121.437320°
DWR ID	DWR_NA0001_04_s_2012_201				
Comment Code					
FE : Fence					
Inspector Comment					
Privacy fence within 10-ft of the levee toe obstruct access and visibility.

03/16/2012 Wood privacy fence completely obstructs access and visibility.

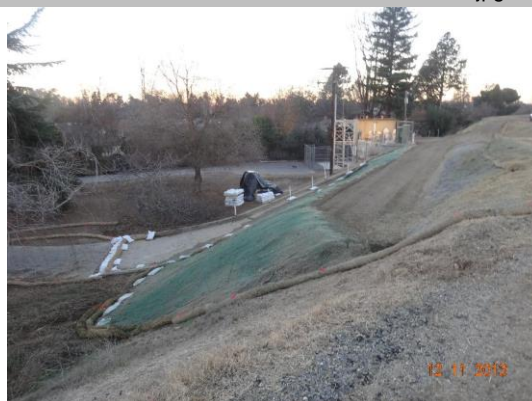
Photo 1 of 3 : UCIP_FA_2018_31446_57490.jpg

LM Start	4.61	Rating **	M	Issue No.	762
LM End	4.61	Issue Type +	En	Location *	
Category	Supplemental			GPS Latitude/Longitude	
				Start	End
Item	DWR UCIP Field Study			38.581101 °	38.581101 °
				-121.436502 °	-121.436502 °
DWR ID	24808				
Comment Code					
Inspector Comment					
FS_ID:31446					
DS_ID:24808					
EP_NO: N/A					
Repair Type: Non-Urgent					
Crossing Status: Indicator Found					
UCIP Comments: New construction--need permit and details on crossing.					
FIELD_STRUCT_DESC: 1 of 4: Concrete service box located on waterside (WS) shoulder. Landside (LS) has been regraded. No permit was found for the work. Unable to verify if crossing crosses levee.					
FS Date: 12/13/2013

View of landward side.

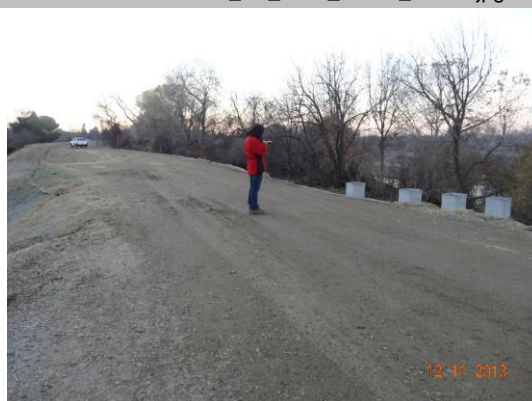
Photo 2 of 3 : UCIP_FA_2018_31446_57489.jpg

View of regraded levee crown with service boxes on waterward slope.

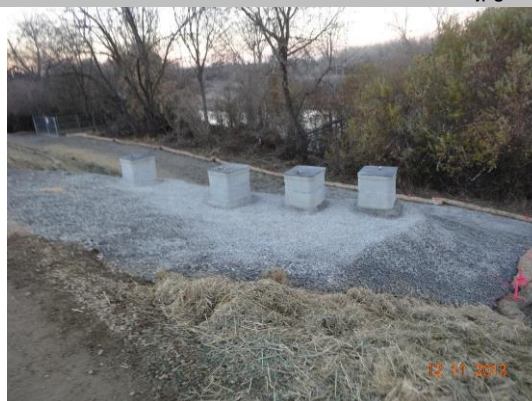
Photo 3 of 3 : UCIP_FA_2018_31446_57488.jpg

LM Start	4.61	Rating **	M	Issue No.	762 (cont)	
LM End	4.61	Issue Type +	En	Location *		
Category	Supplemental			GPS Latitude/Longitude		
				Start	End	
Item	DWR UCIP Field Study			38.581101 °	38.581101 °	
				-121.436502 °	-121.436502 °	
DWR ID	24808					
Comment Code						
Inspector Comment						
FS_ID:31446						
DS_ID:24808						
EP_NO: N/A						
Repair Type: Non-Urgent						
Crossing Status: Indicator Found						
UCIP Comments: New construction--need permit and details on crossing.						
FIELD_STRUCT_DESC: 1 of 4: Concrete service box located on waterside (WS) shoulder. Landside (LS) has been regraded. No permit was found for the work. Unable to verify if crossing crosses levee.						
FS Date: 12/13/2013

Service boxes located on waterward shoulder.

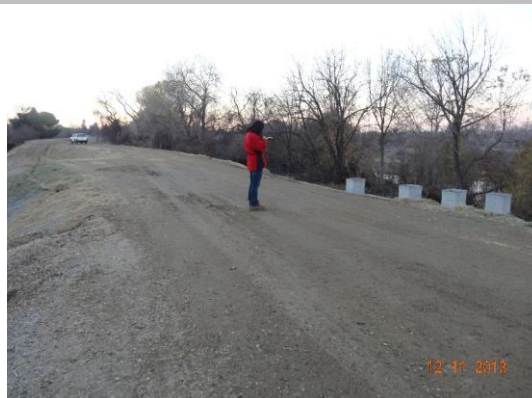
Photo 2 of 3 : UCIP_FA_2018_31447_57492.jpg

FS_ID:31447
DS_ID:24809
EP_NO: N/A
Repair Type: Non-Urgent
Crossing Status: Indicator Found
UCIP Comments: New construction; no permit found; Need additional information about crossings to determine whether crossings penetrate levee.
FIELD_STRUCT_DESC: 2 of 4: Concrete service box located on waterside (WS) shoulder. Landside (LS) has been regraded. No permit was found for the work. Unable to verify if crossing crosses levee.
FS Date: 12/13/2013

View of levee crown at crossings.

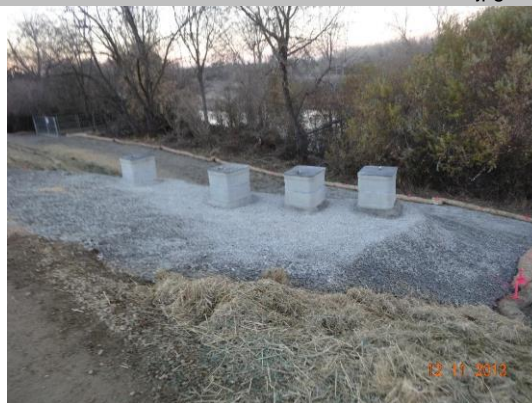
Photo 3 of 3 : UCIP_FA_2018_31447_57491.jpg

View of waterward side.

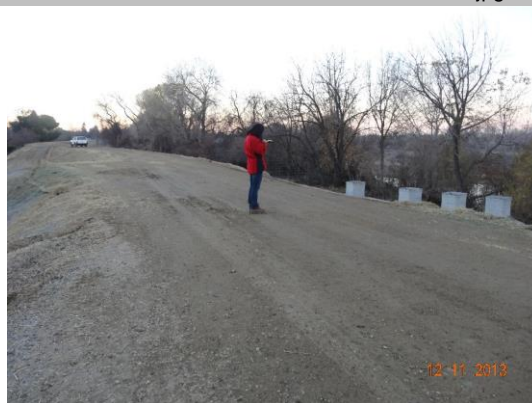
Photo 2 of 3 : UCIP_FA_2018_31448_57495.jpg

LM Start	4.61	Rating **	M	Issue No.	764	
LM End	4.61	Issue Type +	En	Location *		
Category	Supplemental			GPS Latitude/Longitude		
				Start	End	
Item	DWR UCIP Field Study			38.581087 °	38.581087 °	
				-121.436449 °	-121.436449 °	
DWR ID	24810					
Comment Code						
Inspector Comment						
FS_ID:31448						
DS_ID:24810						
EP_NO: N/A						
Repair Type: Non-Urgent						
Crossing Status: Indicator Found						
UCIP Comments: New construction; no permit found; Need additional information about crossings to determine whether crossings penetrate levee.						
FIELD_STRUCT_DESC: 3 of 4: Concrete service box located on waterside (WS) shoulder. Landside (LS) has been regraded. No permit was found for the work. Unable to verify if crossing crosses levee.						
FS Date: 12/13/2013

View of levee crown.

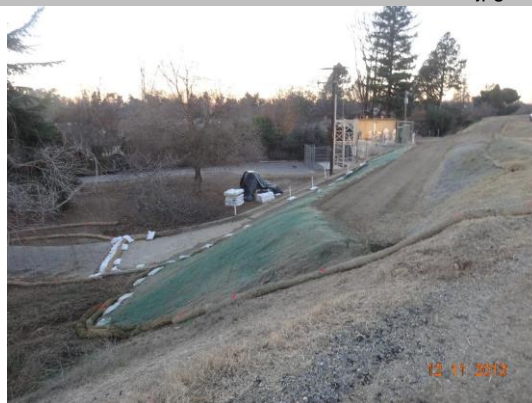
Photo 1 of 3 : UCIP_FA_2018_31449_57499.jpg

LM Start	4.61	Rating **	M	Issue No.	765	
LM End	4.61	Issue Type +	En	Location *		
Category	Supplemental			GPS Latitude/Longitude		
				Start	End	
Item	DWR UCIP Field Study			38.581082 °	38.581082 °	
				-121.436431 °	-121.436431 °	
DWR ID	24811					
Comment Code						
Inspector Comment						
FS_ID:31449						
DS_ID:24811						
EP_NO: N/A						
Repair Type: Non-Urgent						
Crossing Status: Indicator Found						
UCIP Comments: New construction; no permit found; Need additional information about crossings to determine whether crossing penetrate levee.						
FIELD_STRUCT_DESC: 4 of 4: Concrete service box located on waterside (WS) shoulder. Landside (LS) has been regraded. No permit was found for the work. Unable to verify if crossing crosses levee.						
FS Date: 12/13/2013

View of landward side.

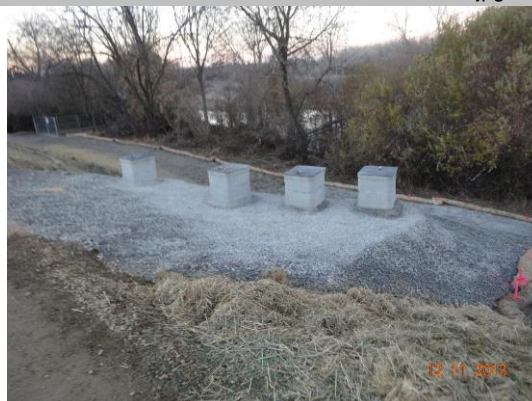
Photo 3 of 3 : UCIP_FA_2018_31449_57497.jpg

LM Start	4.61	Rating **	M	Issue No.	765 (cont)	
LM End	4.61	Issue Type +	En	Location *		
Category	Supplemental			GPS Latitude/Longitude		
				Start	End	
Item	DWR UCIP Field Study			38.581082 °	38.581082 °	
				-121.436431 °	-121.436431 °	
DWR ID	24811					
Comment Code						
Inspector Comment						
FS_ID:31449						
DS_ID:24811						
EP_NO: N/A						
Repair Type: Non-Urgent						
Crossing Status: Indicator Found						
UCIP Comments: New construction; no permit found; Need additional information about crossings to determine whether crossing penetrate levee.						
FIELD_STRUCT_DESC: 4 of 4: Concrete service box located on waterside (WS) shoulder. Landside (LS) has been regraded. No permit was found for the work. Unable to verify if crossing crosses levee.						
FS Date: 12/13/2013

View of landward side--service boxes located on landward slope.

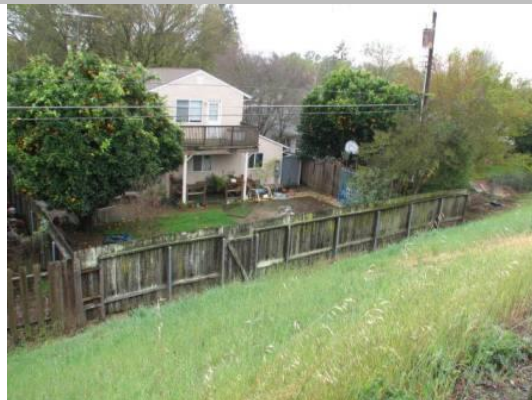
Photo 1 of 1 : FA_2018_NA0001_55_40_20180911_00033.jpg

LM Start	4.73	Rating **	U	Issue No.	40
LM End	4.73	Issue Type +	En	Location *	LS
Category	Earthen Levee			GPS Latitude/Longitude	
				Start	End
Item	Encroachments			38.580759 °	38.580759 °
				-121.434294 °	-121.434294 °
DWR ID	DWR_NA0001_04_s_2012_40				
Comment Code					
FE : Fence					
Inspector Comment					
Privacy fence within 10-ft of the levee toe obstruct access and visibility.

03/16/2012 Wood privacy fence completely obstructs access and visibility.

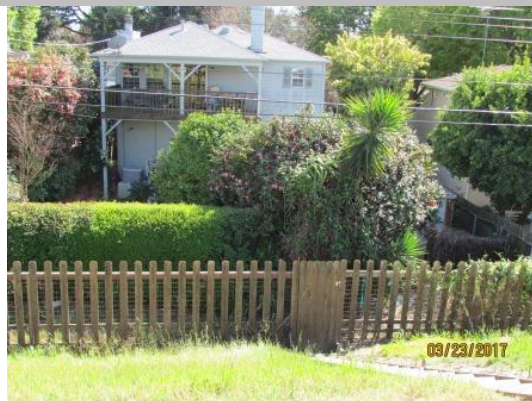
Photo 1 of 1 : FA_2018_NA0001_55_41_20180911_00034.jpg

LM Start	4.74	Rating **	M	Issue No.	41
LM End	4.74	Issue Type +	En	Location *	LS
Category	Earthen Levee			GPS Latitude/Longitude	
				Start	End
Item	Encroachments			38.580753 °	38.580753 °
				-121.434077 °	-121.434077 °
DWR ID	DWR_NA0001_04_s_2012_41				
Comment Code					
FE : Fence					
Inspector Comment					
Privacy fence and landscaping within 10-ft of the levee toe obstruct access and visibility.

View of the fence at the levee toe.

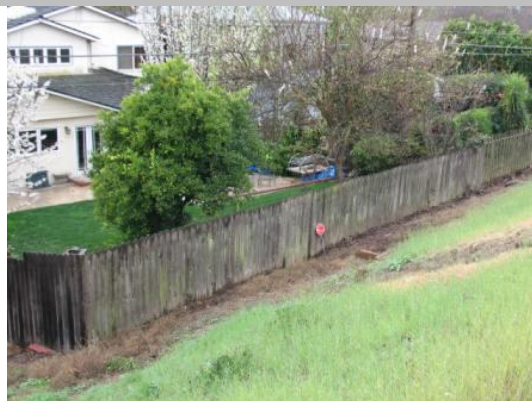
Photo 1 of 1 : FA_2018_NA0001_55_42_20180911_00035.jpg

LM Start	4.76	Rating **	U	Issue No.	42
LM End	4.76	Issue Type +	En	Location *	LS
Category	Earthen Levee			GPS Latitude/Longitude	
				Start	End
Item	Encroachments			38.580744 °	38.580744 °
				-121.433868 °	-121.433868 °
DWR ID	DWR_NA0001_04_s_2012_42				
Comment Code					
FE : Fence					
Inspector Comment					
Privacy fence within 10-ft of the levee toe obstruct access and visibility.

03/16/2012 Wood privacy fence completely obstructs access and visibility.

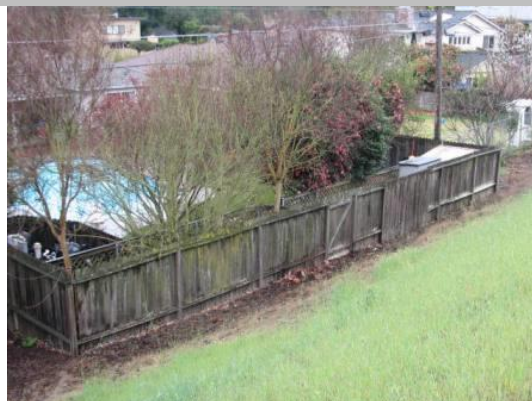
Photo 1 of 1 : FA_2018_NA0001_55_43_20180911_00036.jpg

LM Start	4.78	Rating **	U	Issue No.	43
LM End	4.78	Issue Type +	En	Location *	LS
Category	Earthen Levee			GPS Latitude/Longitude	
				Start	End
Item	Encroachments			38.580731 °	38.580731 °
				-121.433490 °	-121.433490 °
DWR ID	DWR_NA0001_04_s_2012_43				
Comment Code					
FE : Fence					
Inspector Comment					
Privacy fence and storage sheds within 10-ft of the levee toe obstruct access and visibility.

03/16/2012 Wood privacy fence completely obstructs access and visibility.

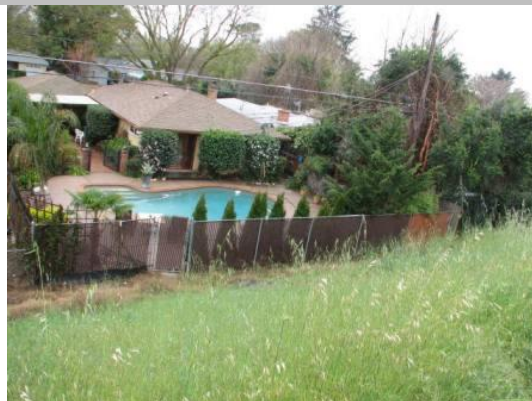
Photo 1 of 1 : FA_2018_NA0001_55_205_20180911_00174.jpg

LM Start	4.83	Rating **	U	Issue No.	205
LM End	4.83	Issue Type +	En	Location *	LS
Category	Earthen Levee			GPS Latitude/Longitude	
				Start	End
Item	Encroachments			38.580723 °	38.580723 °
				-121.432577 °	-121.432577 °
DWR ID	DWR_NA0001_04_s_2012_205				
Comment Code					
FE : Fence					
Inspector Comment					
Privacy fence and landscape prunings on levee slope and toe.prunings removed. Fence obstructs access and visibility.

03/16/2012 Chainlink fence with privacy slats obstructs visibility and access.

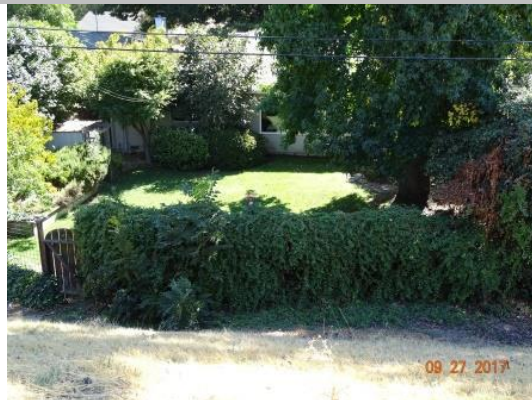
Photo 1 of 1 : FA_2018_NA0001_55_44_20180911_00037.jpg

LM Start	4.85	Rating **	M	Issue No.	44
LM End	4.85	Issue Type +	En	Location *	LS
Category	Earthen Levee			GPS Latitude/Longitude	
				Start	End
Item	Vegetation			38.580747 °	38.580747 °
				-121.432039 °	-121.432039 °
DWR ID	DWR_NA0001_04_f_2018_44				
Comment Code					
V6 : Landscaping					
Inspector Comment					
Vines on wire fence obstruct visibility.

View of the vegetation at the levee toe.

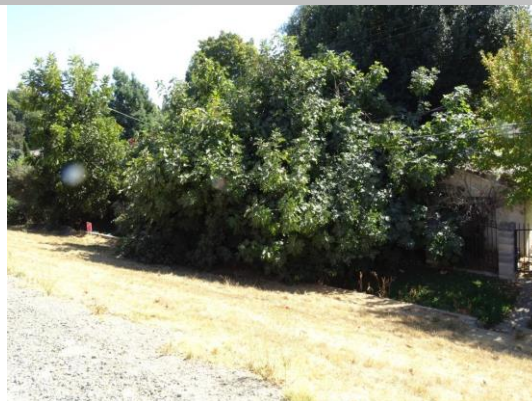
Photo 1 of 2 : FA_2018_NA0001_55_206_20181026_00284.jpg

LM Start	4.87	Rating **	U	Issue No.	206
LM End	4.87	Issue Type +	En	Location *	LS
Category	Earthen Levee			GPS Latitude/Longitude	
				Start	End
Item	Vegetation			38.580778 °	38.580778 °
				-121.431704 °	-121.431704 °
DWR ID	DWR_NA0001_04_s_2012_206				
Comment Code					
V6 : Landscaping					
Inspector Comment					
Fig tree obstructs visibility and access.

View of landscaping that obstructs visibility and access. Fall 2018

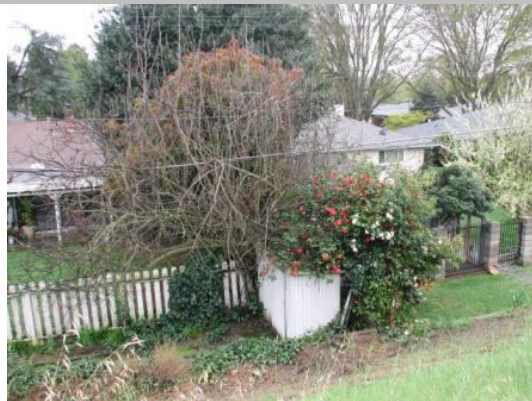
Photo 2 of 2 : FA_2018_NA0001_55_206_20180911_00175.jpg

03/16/2012 Landscaping obstructs visibility and access.

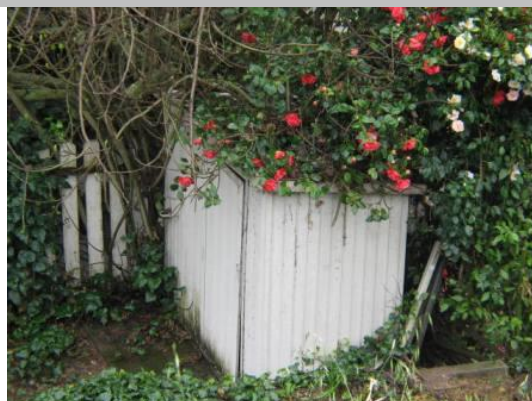
Photo 1 of 1 : FA_2018_NA0001_55_96_20180911_00082.jpg

LM Start	4.87	Rating **	U	Issue No.	96
LM End	4.87	Issue Type +	En	Location *	LS
Category	Earthen Levee			GPS Latitude/Longitude	
				Start	End
Item	Encroachments			38.580767 °	38.580767 °
				-121.431684 °	-121.431684 °
DWR ID	DWR_NA0001_04_s _ 2012_96				
Comment Code					
BU : Building					
Inspector Comment					
Wooden shed is located beneath the fig tree.

3/16/2012 Structure is within 15' of levee toe.

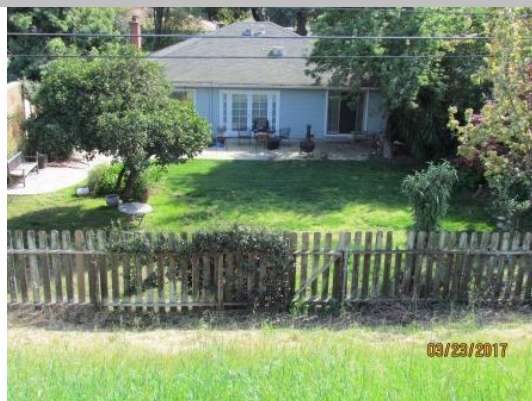
Photo 1 of 1 : FA_2018_NA0001_55_265_20180911_00210.jpg

LM Start	4.89	Rating **	M	Issue No.	265
LM End	4.89	Issue Type +	En	Location *	LS
Category	Earthen Levee			GPS Latitude/Longitude	
				Start	End
Item	Encroachments			38.580794 °	38.580794 °
				-121.431453 °	-121.431453 °
DWR ID	DWR_NA0001_04_s _ 2017_265				
Comment Code					
FE : Fence					
Inspector Comment					
Fence at levee toe.

View of the fence at the levee toe.

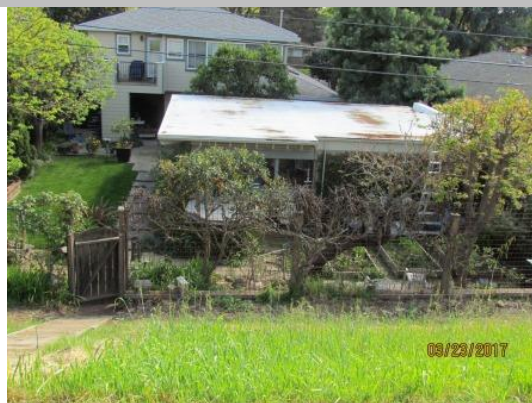
Photo 1 of 1 : FA_2018_NA0001_55_207_20180911_00176.jpg

LM Start	4.90	Rating **	M	Issue No.	207
LM End	4.90	Issue Type +	En	Location *	LS
Category	Earthen Levee			GPS Latitude/Longitude	
				Start	End
Item	Encroachments			38.580806 °	38.580806 °
				-121.431266 °	-121.431266 °
DWR ID	DWR_NA0001_04_s _ 2012_207				
Comment Code					
FE : Fence					
Inspector Comment					
Fence at levee toe.

View of the fence at the levee toe.

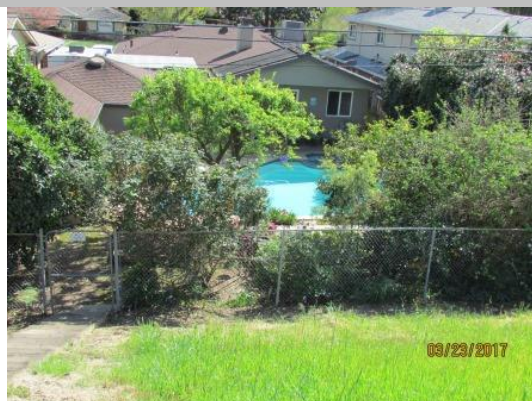
Photo 1 of 1 : FA_2018_NA0001_55_264_20180911_00209.jpg

LM Start	4.91	Rating **	M	Issue No.	264
LM End	4.91	Issue Type +	En	Location *	LS
Category	Earthen Levee			GPS Latitude/Longitude	
				Start	End
Item	Encroachments			38.580820 °	38.580820 °
				-121.431045 °	-121.431045 °
DWR ID	DWR_NA0001_04_s_2017_264				
Comment Code					
FE : Fence					
Inspector Comment					
Chain-link fence at levee toe.

View of the fence at the levee toe.

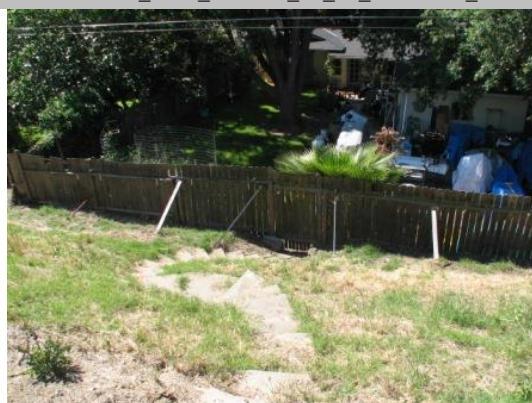
Photo 1 of 1 : FA_2018_NA0001_55_45_20180911_00038.jpg

LM Start	4.93	Rating **	U	Issue No.	45
LM End	4.93	Issue Type +	En	Location *	LS
Category	Earthen Levee			GPS Latitude/Longitude	
				Start	End
Item	Encroachments			38.580844 °	38.580844 °
				-121.430672 °	-121.430672 °
DWR ID	DWR_NA0001_04_s_2012_45				
Comment Code					
FE : Fence					
Inspector Comment					
Wooden fence with bracing obstructs access and visibility.

Wooden fence and braces obstruct access and visibility.

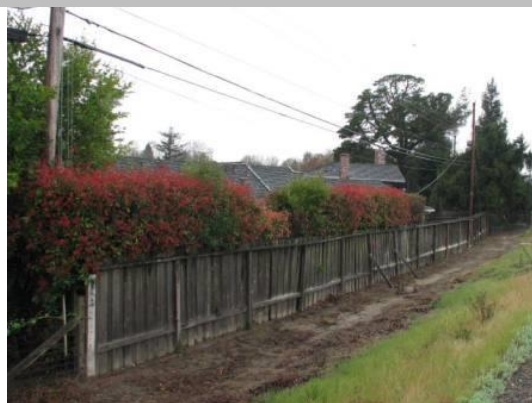
Photo 1 of 1 : FA_2018_NA0001_55_46_20180911_00039.jpg

LM Start	5.08	Rating **	U	Issue No.	46
LM End	5.08	Issue Type +	En	Location *	LS
Category	Earthen Levee			GPS Latitude/Longitude	
				Start	End
Item	Encroachments			38.581000 °	38.581000 °
				-121.427826 °	-121.427826 °
DWR ID	DWR_NA0001_04_s_2012_46				
Comment Code					
FE : Fence					
Inspector Comment					
Privacy fence and landscaping within 10-ft of the levee toe obstruct access and visibility.

03/16/2012 Wood privacy fence completely obstructs access and visibility.

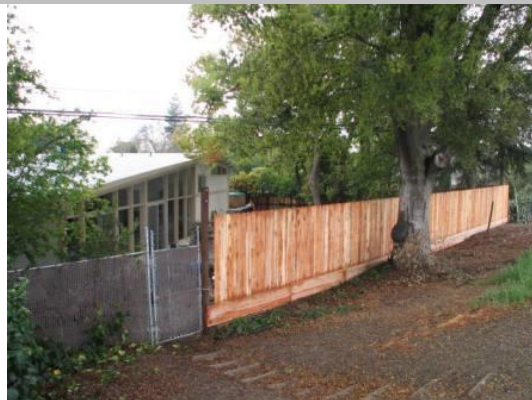
Photo 1 of 1 : FA_2018_NA0001_55_208_20180911_00177.jpg

LM Start	5.13	Rating **	U	Issue No.	208
LM End	5.13	Issue Type +	En	Location *	LS
Category	Earthen Levee			GPS Latitude/Longitude	
				Start	End
Item	Encroachments			38.580882 °	38.580882 °
				-121.427038 °	-121.427038 °
DWR ID	DWR_NA0001_04_s_2012_208				
Comment Code					
FE : Fence					
Inspector Comment					
Privacy fence and landscaping within 10-ft of the levee toe obstruct access and visibility.

03/16/2012 Wood privacy fence completely obstructs access and visibility.

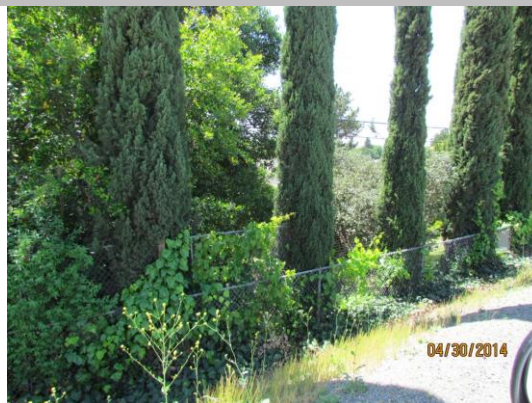
Photo 1 of 1 : FA_2018_NA0001_55_47_20180911_00040.jpg

LM Start	5.15	Rating **	M	Issue No.	47
LM End	5.15	Issue Type +	En	Location *	LS
Category	Earthen Levee			GPS Latitude/Longitude	
				Start	End
Item	Encroachments			38.580773 °	38.580773 °
				-121.426691 °	-121.426691 °
DWR ID	DWR_NA0001_04_s_2012_47				
Comment Code					
FE : Fence					
Inspector Comment					
Chain link fence, helix sky pencil, and landscaping within 10-ft of the levee toe obstruct access and visibility.

View of the fence and vegetation at the landside levee toe.

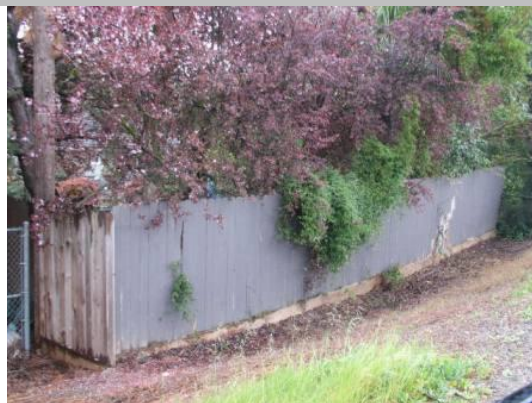
Photo 1 of 1 : FA_2018_NA0001_55_48_20180911_00041.jpg

LM Start	5.17	Rating **	U	Issue No.	48
LM End	5.17	Issue Type +	En	Location *	LS
Category	Earthen Levee			GPS Latitude/Longitude	
				Start	End
Item	Encroachments			38.580622 °	38.580622 °
				-121.426372 °	-121.426372 °
DWR ID	DWR_NA0001_04_s_2012_48				
Comment Code					
FE : Fence					
Inspector Comment					
Wood privacy fence and landscaping within 10-ft of the levee toe obstruct access and visibility.

03/16/2012 Wood privacy fence completely obstructs access and visibility.

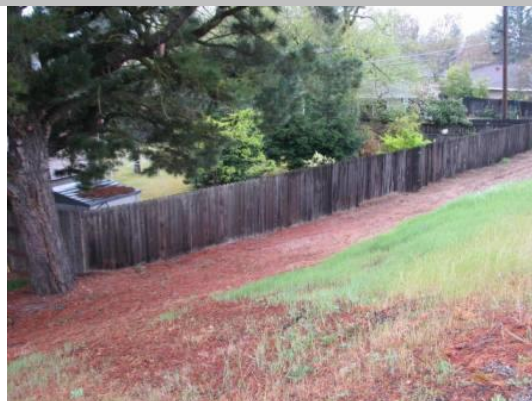
Photo 1 of 1 : FA_2018_NA0001_55_49_20180911_00042.jpg

LM Start	5.45	Rating **	U	Issue No.	49
LM End	5.45	Issue Type +	En	Location *	LS
Category	Earthen Levee			GPS Latitude/Longitude	
				Start	End
Item	Encroachments			38.577526 °	38.577526 °
				-121.423349 °	-121.423349 °
DWR ID	DWR_NA0001_04_s_2012_49				
Comment Code					
FE : Fence					
Inspector Comment					
Wood privacy fence within 10-ft of the levee toe obstruct access and visibility.

03/16/2012 Wood privacy fence completely obstructs access and visibility.

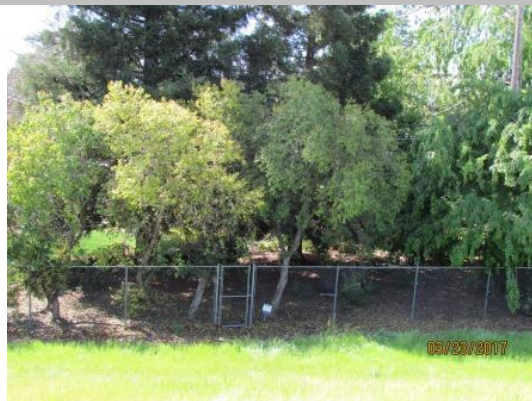
Photo 1 of 1 : FA_2018_NA0001_55_263_20180911_00208.jpg

LM Start	5.48	Rating **	M	Issue No.	263	
LM End	5.48	Issue Type +	En	Location *	LS	
Category	Earthen Levee			GPS Latitude/Longitude		
				Start		End
Item	Encroachments			38.577065 °		38.577065 °
				-121.423255 °		-121.423255 °
DWR ID	DWR_NA0001_04_s_2017_263					
Comment Code						
FE : Fence						
Inspector Comment						
Chain-link fence at levee toe.

View of the fence at the levee toe.

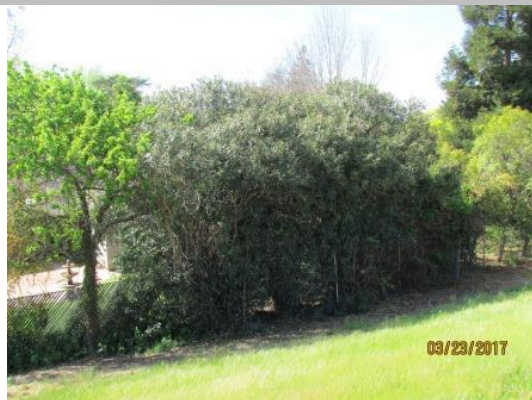
Photo 1 of 1 : FA_2018_NA0001_55_209_20180911_00178.jpg

LM Start	5.49	Rating **	M	Issue No.	209
LM End	5.49	Issue Type +	En	Location *	LS
Category	Earthen Levee			GPS Latitude/Longitude	
				Start	End
Item	Vegetation			38.576878 °	38.576878 °
				-121.423234 °	-121.423234 °
DWR ID	DWR_NA0001_04_s_2012_209				
Comment Code					
V6 : Landscaping					
Inspector Comment					
Oleanders within 10-ft of the levee toe obstruct access and visibility.

View of the shrubs at the levee toe.

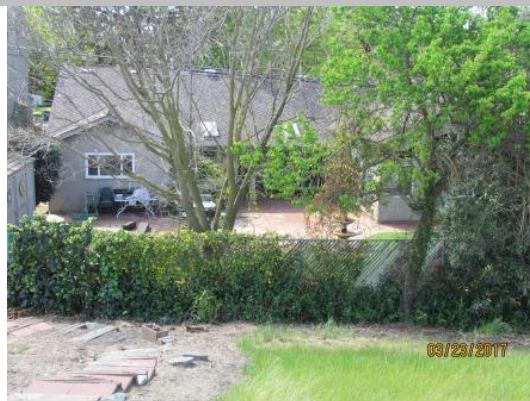
Photo 1 of 1 : FA_2018_NA0001_55_262_20180911_00207.jpg

LM Start	5.50	Rating **	U	Issue No.	262
LM End	5.50	Issue Type +	En	Location *	LS
Category	Earthen Levee			GPS Latitude/Longitude	
				Start	End
Item	Encroachments			38.576796 °	38.576796 °
				-121.423221 °	-121.423221 °
DWR ID	DWR_NA0001_04_s_2017_262				
Comment Code					
FE : Fence					
Inspector Comment					
Fence obstructing visibility and access at landside levee toe.

View of the fence at the levee toe.

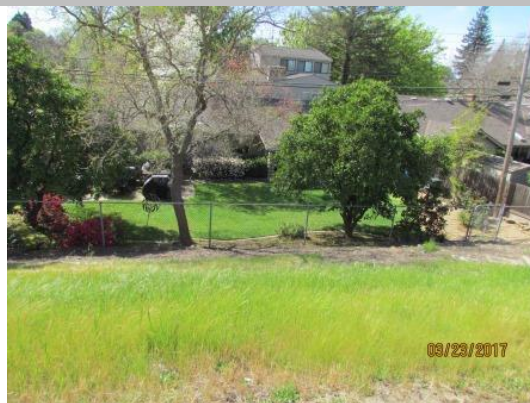
Photo 1 of 1 : FA_2018_NA0001_55_261_20180911_00206.jpg

LM Start	5.51	Rating **	M	Issue No.	261
LM End	5.51	Issue Type +	En	Location *	LS
Category	Earthen Levee			GPS Latitude/Longitude	
				Start	End
Item	Encroachments			38.576579 °	38.576579 °
				-121.423201 °	-121.423201 °
DWR ID	DWR_NA0001_04_s_2017_261				
Comment Code					
FE : Fence					
Inspector Comment					
Chainlink fence at levee toe.

View of the fence at the levee toe.

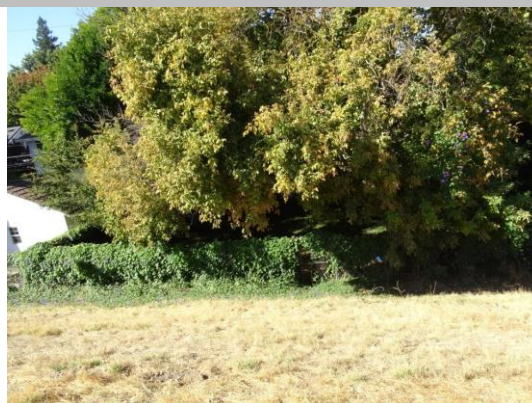
Photo 1 of 1 : FA_2018_NA0001_55_276_20181024_00283.jpg

LM Start	5.58	Rating **	M	Issue No.	276
LM End	5.58	Issue Type +	En	Location *	LS
Category	Earthen Levee			GPS Latitude/Longitude	
				Start	End
Item	Vegetation			38.575573 °	38.575573 °
				-121.423161 °	-121.423161 °
DWR ID	DWR_NA0001_04_f_2018_276				
Comment Code					
V6 : Landscaping					
Inspector Comment					
Vegetation on chainlink fence obstructs view of levee toe.

View of vegetation on chainlink fence that obstructs view of levee toe.
Fall 2018

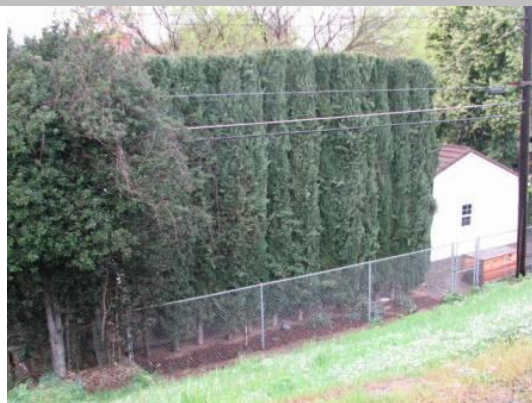
Photo 1 of 1 : FA_2018_NA0001_55_52_20180911_00044.jpg

LM Start	5.60	Rating **	U	Issue No.	52
LM End	5.60	Issue Type +	En	Location *	LS
Category	Earthen Levee			GPS Latitude/Longitude	
				Start	End
Item	Vegetation			38.575379 °	38.575379 °
				-121.423201 °	-121.423201 °
DWR ID	DWR_NA0001_04_s_2012_52				
Comment Code					
V6 : Landscaping					
Inspector Comment					
Helix sky pencil trees within 10-ft of the levee toe obstruct visibility and access.

03/16/2012 Landscaping obstructs visibility and access.

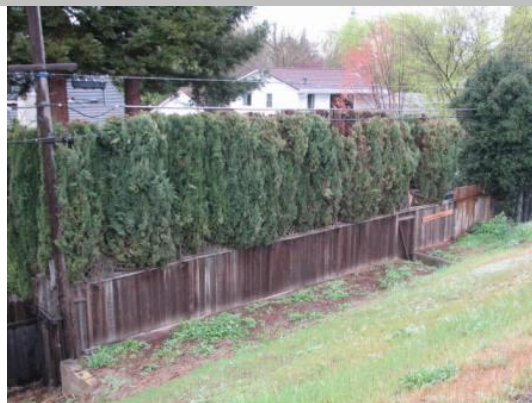
Photo 1 of 1 : FA_2018_NA0001_55_53_20180911_00045.jpg

LM Start	5.61	Rating **	U	Issue No.	53
LM End	5.61	Issue Type +	En	Location *	LS
Category	Earthen Levee			GPS Latitude/Longitude	
				Start	End
Item	Vegetation			38.575250 °	38.575250 °
				-121.423240 °	-121.423240 °
DWR ID	DWR_NA0001_04_s_2012_53				
Comment Code					
V6 : Landscaping					
Inspector Comment					
Wood privacy fence, helix sky pencil, vines, and landscaping within 10-ft of the levee toe obstruct access and visibility. Cement stairs up levee slope.

03/16/2012 Landscaping and fence obstruct visibility and access.

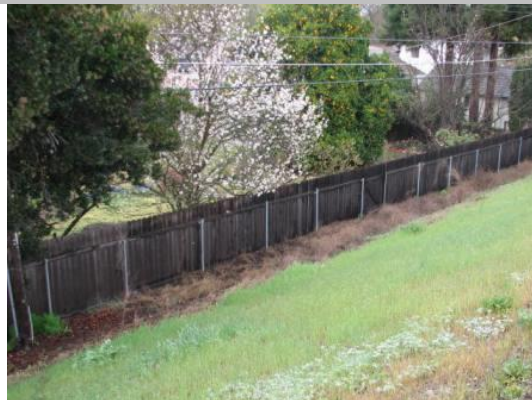
Photo 1 of 1 : FA_2018_NA0001_55_54_20180911_00046.jpg

LM Start	5.62	Rating **	U	Issue No.	54
LM End	5.62	Issue Type +	En	Location *	LS
Category	Earthen Levee			GPS Latitude/Longitude	
				Start	End
Item	Encroachments			38.575024 °	38.575024 °
				-121.423277 °	-121.423277 °
DWR ID	DWR_NA0001_04_s_2012_54				
Comment Code					
FE : Fence					
Inspector Comment					
Wood privacy fence and landscaping within 10-ft of the levee toe obstruct access and visibility.

03/16/2012 Wood privacy fence completely obstructs access and visibility.

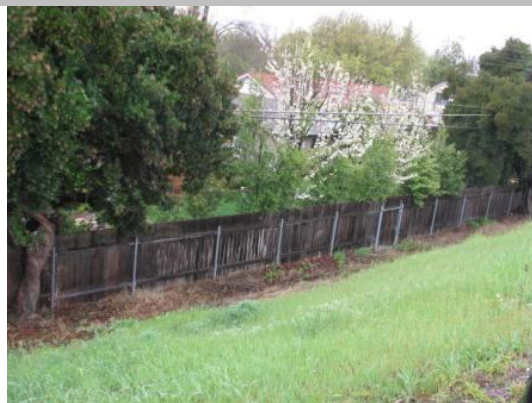
Photo 1 of 1 : FA_2018_NA0001_55_55_20180911_00047.jpg

LM Start	5.64	Rating **	U	Issue No.	55
LM End	5.64	Issue Type +	En	Location *	LS
Category	Earthen Levee			GPS Latitude/Longitude	
				Start	End
Item	Encroachments			38.574786 °	38.574786 °
				-121.423324 °	-121.423324 °
DWR ID	DWR_NA0001_04_s_2012_55				
Comment Code					
FE : Fence					
Inspector Comment					
Wood privacy fence within 10-ft of the levee toe obstructs visibility.

03/16/2012 Wood privacy fence completely obstructs access and visibility.

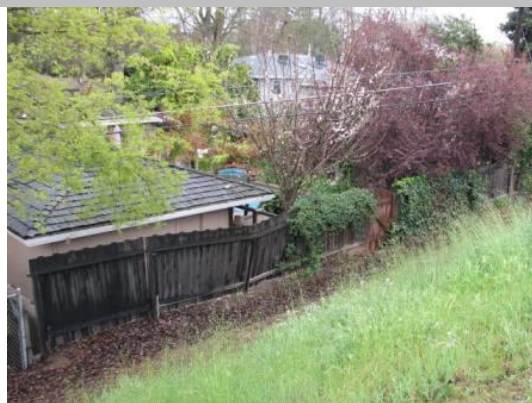
Photo 1 of 1 : FA_2018_NA0001_55_57_20180911_00048.jpg

LM Start	5.70	Rating **	U	Issue No.	57
LM End	5.70	Issue Type +	En	Location *	LS
Category	Earthen Levee			GPS Latitude/Longitude	
				Start	End
Item	Encroachments			38.573927 °	38.573927 °
				-121.423480 °	-121.423480 °
DWR ID	DWR_NA0001_04_s_2012_57				
Comment Code					
FE : Fence					
Inspector Comment					
Wood privacy fence with ivy obstructs visibility.

03/16/2012 Wood privacy fence completely obstructs access and visibility.

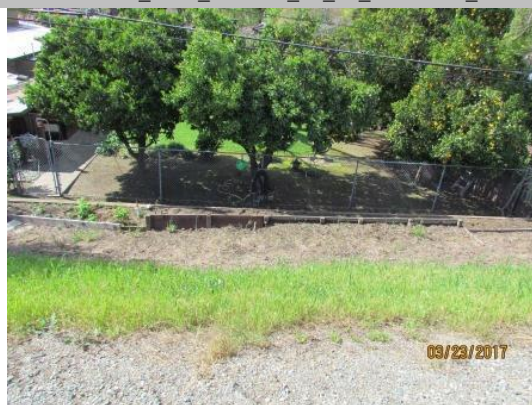
Photo 1 of 1 : FA_2018_NA0001_55_58_20180911_00049.jpg

LM Start	5.73	Rating **	M	Issue No.	58
LM End	5.73	Issue Type +	En	Location *	LS
Category	Earthen Levee			GPS Latitude/Longitude	
				Start	End
Item	Vegetation			38.573501 °	38.573501 °
				-121.423602 °	-121.423602 °
DWR ID	DWR_NA0001_04_s_2012_58				
Comment Code					
V6 : Landscaping					
Inspector Comment					
Garden built on levee slope.

View of the garden at the levee toe.

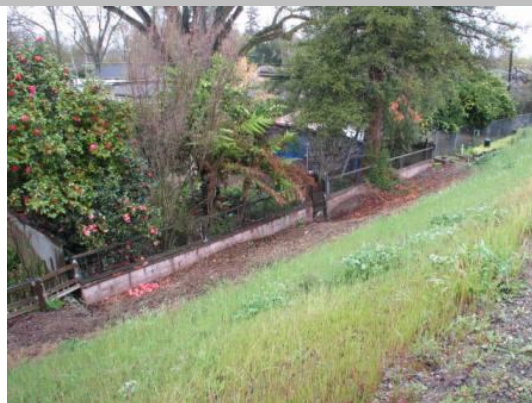
Photo 1 of 1 : FA_2018_NA0001_55_59_20180911_00050.jpg

LM Start	5.73	Rating **	U	Issue No.	59
LM End	5.73	Issue Type +	En	Location *	LS
Category	Earthen Levee			GPS Latitude/Longitude	
				Start	End
Item	Encroachments			38.573403 °	38.573403 °
				-121.423642 °	-121.423642 °
DWR ID	DWR_NA0001_04_s_2012_59				
Comment Code					
FE : Fence					
Inspector Comment					
Brick fence and landscaping within 10-ft of the levee toe obstructs access and visibility.

03/16/2012 Fence and landscaping obstruct visibility and access.

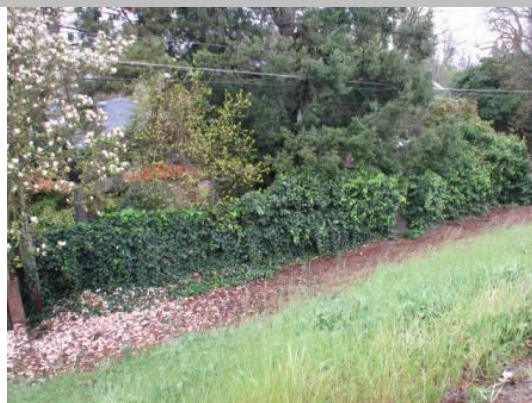
Photo 1 of 1 : FA_2018_NA0001_55_61_20180911_00051.jpg

LM Start	5.78	Rating **	U	Issue No.	61
LM End	5.78	Issue Type +	En	Location *	LS
Category	Earthen Levee			GPS Latitude/Longitude	
				Start	End
Item	Vegetation			38.572827 °	38.572827 °
				-121.423786 °	-121.423786 °
DWR ID	DWR_NA0001_04_s_2012_61				
Comment Code					
V6 : Landscaping					
Inspector Comment					
Dense ivy and shrubs are within 10-ft of the levee toe.

03/16/2012 Landscaping obstructs access and visibility.

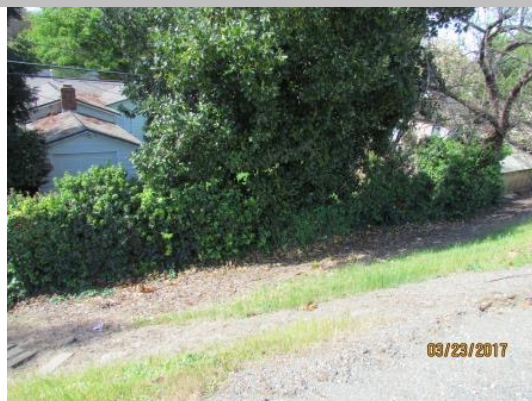
Photo 1 of 1 : FA_2018_NA0001_55_64_20180911_00053.jpg

LM Start	5.82	Rating **	M	Issue No.	64
LM End	5.82	Issue Type +	En	Location *	LS
Category	Earthen Levee			GPS Latitude/Longitude	
				Start	End
Item	Vegetation			38.572207 °	38.572207 °
				-121.423933 °	-121.423933 °
DWR ID	DWR_NA0001_04_s_2012_64				
Comment Code					
V6 : Landscaping					
Inspector Comment					
Dense shrubs on levee toe obstruct visibility and access.

View of the shrubs at the levee toe.

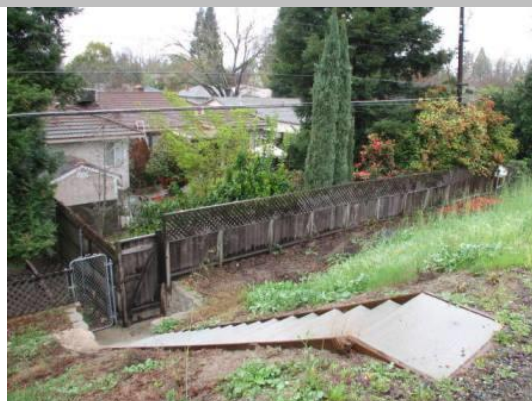
Photo 1 of 1 : FA_2018_NA0001_55_65_20180911_00054.jpg

LM Start	5.83	Rating **	U	Issue No.	65
LM End	5.83	Issue Type +	En	Location *	LS
Category	Earthen Levee			GPS Latitude/Longitude	
				Start	End
Item	Encroachments			38.572067 °	38.572067 °
				-121.423970 °	-121.423970 °
DWR ID	DWR_NA0001_04_s_2012_65				
Comment Code					
FE : Fence					
Inspector Comment					
Extended privacy fence and retaining wall within 10-ft of levee toe.

03/16/2012 Wood privacy fence completely obstructs access and visibility.

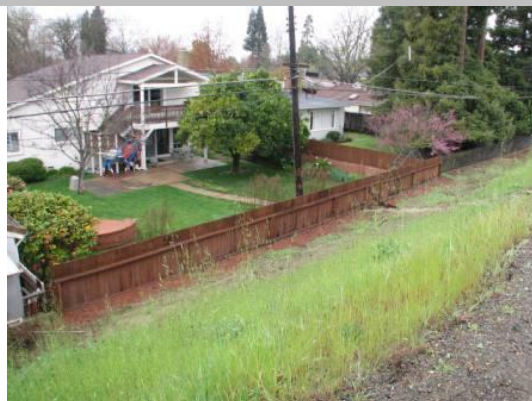
Photo 1 of 1 : FA_2018_NA0001_55_210_20180911_00179.jpg

LM Start	5.85	Rating **	U	Issue No.	210
LM End	5.85	Issue Type +	En	Location *	LS
Category	Earthen Levee			GPS Latitude/Longitude	
				Start	End
Item	Encroachments			38.571733 °	38.571733 °
				-121.424055 °	-121.424055 °
DWR ID	DWR_NA0001_04_s_2012_210				
Comment Code					
FE : Fence					
Inspector Comment					
Privacy fence and retaining wall are within 10-ft of levee toe.

03/16/2012 Wood privacy fence completely obstructs access and visibility.

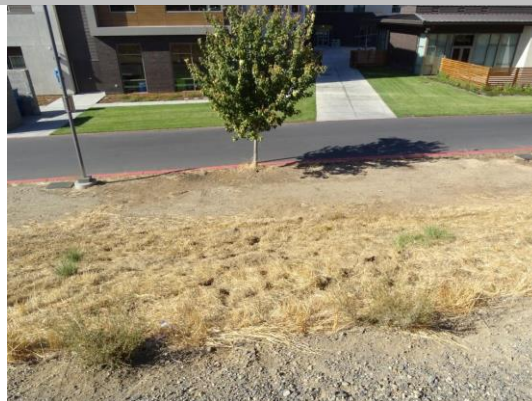
Photo 1 of 1 : FA_2018_NA0001_55_271_20181024_00279.jpg

LM Start	6.29	Rating **	M	Issue No.	271
LM End	6.29	Issue Type +	Ma	Location *	LS
Category	Earthen Levee			GPS Latitude/Longitude	
				Start	End
Item	Animal Control			38.565472 °	38.565472 °
				-121.423240 °	-121.423240 °
DWR ID	DWR_NA0001_04_f_2018_271				
Comment Code					
A3 : No rodents visible, but rodent burrows visible; need to backfill and compact or grout burrows.					
Inspector Comment					
Backfill rodent holes.

View of animal holes. Fall 2018

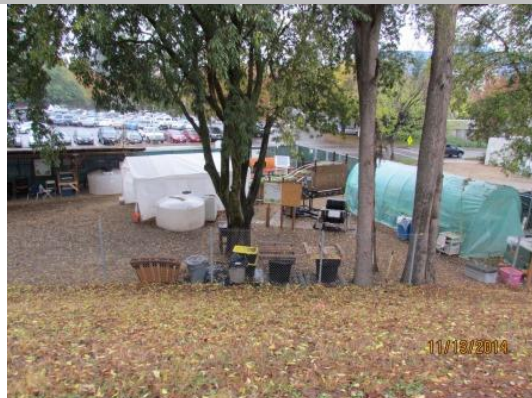
Photo 1 of 1 : FA_2018_NA0001_55_51_20180911_00043.jpg

LM Start	6.62	Rating **	M	Issue No.	51
LM End	6.62	Issue Type +	En	Location *	LS
Category	Earthen Levee			GPS Latitude/Longitude	
				Start	End
Item	Encroachments			38.561117°	38.561117°
				-121.420749°	-121.420749°
DWR ID	DWR_NA0001_04_f_2013_51				
Comment Code					
MA : Material					
Inspector Comment					
Pipe and other material stored within 10 feet of landside levee toe.

View of the material stored at the landside levee toe.

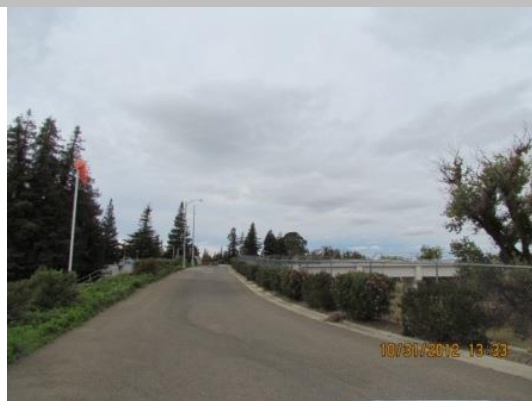
Photo 1 of 1 : FA_2018_NA0001_55_140_20180911_00121.jpg

LM Start	6.82	Rating **	M	Issue No.	140
LM End	6.94	Issue Type +	En	Location *	WS
Category	Earthen Levee			GPS Latitude/Longitude	
				Start	End
Item	Vegetation			38.559152°	38.558115°
				-121.418108°	-121.416328°
DWR ID	DWR_NA0001_04_f_2012_140				
Comment Code					
V6 : Landscaping					
Inspector Comment					
Bushes at waterside hinge obstruct visibility of waterside slope from levee crown.

View of landscaping at waterside hinge obstructing visibility.

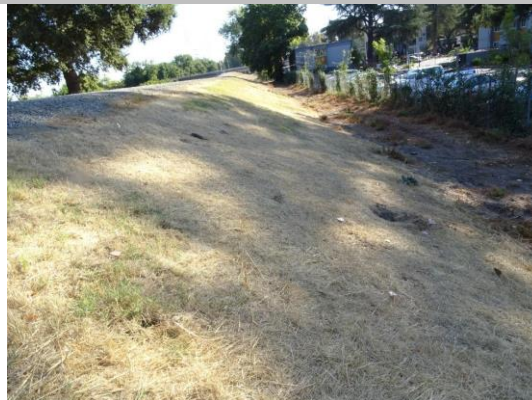
Photo 1 of 1 : FA_2018_NA0001_55_266_20181024_00276.jpg

LM Start	7.20	Rating **	M	Issue No.	266
LM End	7.20	Issue Type +	Ma	Location *	LS
Category	Earthen Levee			GPS Latitude/Longitude	
				Start	End
Item	Animal Control			38.557995 °	38.557995 °
				-121.411579 °	-121.411579 °
DWR ID	DWR_NA0001_04_f_2018_266				
Comment Code					
A3 : No rodents visible, but rodent burrows visible; need to backfill and compact or grout burrows.					
Inspector Comment					
Backfill rodent burrows.

View of animal burrows. Fall 2018

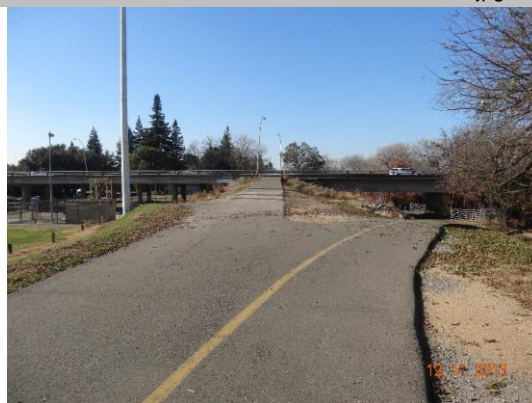
Photo 1 of 3 : UCIP_FA_2018_30023_55394.jpg

Comment Code						
Inspector Comment						
FS_ID:30023 DS_ID:24319 EP_NO: 3596 Repair Type: Non-Urgent Crossing Status: Indicator Found UCIP Comments: 12/11/2013 Need to contact owners to determine how crossing was abandoned. (DWR UCIP - O. Magana) FIELD_STRUCT_DESC: *ABANDONED* [Sump No. 91] 4 of 4: 48-inch corrugated metal (CM) drainage pipe through the levee, 20 feet below the crown. Pump station is also referenced as the Power Inn Road Plant. Two corrugated metal (CM) cutoff walls around pipe under each shoulder. Slide gate with control pedestal in CM pipe riser located on the waterside (WS) slope. Reinforced concrete discharge box is located on the WS toe. Flap gate is located on the WS end. Slide gate with control pedestal in collection sump located on the landside (LS). 60-inch discharge pipe extends from box across the berm to the riverbank. Pumping plant is located on the LS toe. (48-inch pipe abandoned and CM riser cut 2 feet below ground surface authorized under Permit No. 3596A, 1998 – City of Sacramento; three 30-inch and one 48-inch pipes authorized under Permit No. 3596, 3596A, 1962 - County of Sacramento Manlove Drainage Assessment District; 60-inch pipe authorized under Permit No. 5894, 1970 - City of Sacramento) [Additional Reference(s): DWR Levee Log, 2002] FS Date: 12/11/2013

Overview of levee crown at crossings.

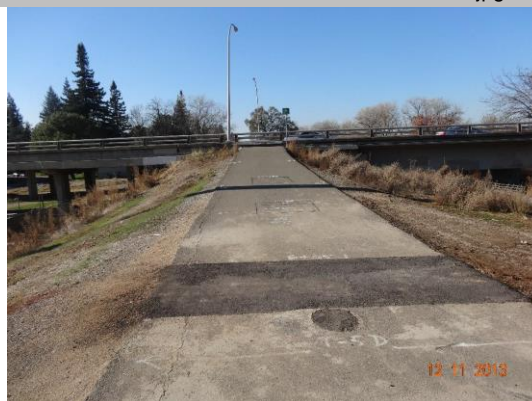
Photo 2 of 3 : UCIP_FA_2018_30023_55392.jpg

Comment Code						
Inspector Comment						
FS_ID:30023 DS_ID:24319 EP_NO: 3596 Repair Type: Non-Urgent Crossing Status: Indicator Found UCIP Comments: 12/11/2013 Need to contact owners to determine how crossing was abandoned. (DWR UCIP - O. Magana) FIELD_STRUCT_DESC: *ABANDONED* [Sump No. 91] 4 of 4: 48-inch corrugated metal (CM) drainage pipe through the levee, 20 feet below the crown. Pump station is also referenced as the Power Inn Road Plant. Two corrugated metal (CM) cutoff walls around pipe under each shoulder. Slide gate with control pedestal in CM pipe riser located on the waterside (WS) slope. Reinforced concrete discharge box is located on the WS toe. Flap gate is located on the WS end. Slide gate with control pedestal in collection sump located on the landside (LS). 60-inch discharge pipe extends from box across the berm to the riverbank. Pumping plant is located on the LS toe. (48-inch pipe abandoned and CM riser cut 2 feet below ground surface authorized under Permit No. 3596A, 1998 – City of Sacramento; three 30-inch and one 48-inch pipes authorized under Permit No. 3596, 3596A, 1962 - County of Sacramento Manlove Drainage Assessment District; 60-inch pipe authorized under Permit No. 5894, 1970 - City of Sacramento) [Additional Reference(s): DWR Levee Log, 2002] FS Date: 12/11/2013

Signs of crossing repair patch section visible on levee crown.

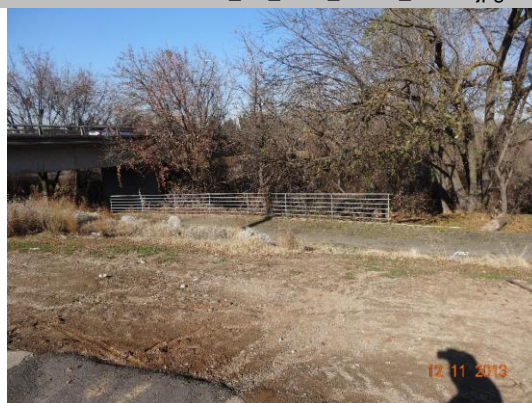
Photo 3 of 3 : UCIP_FA_2018_30023_55397.jpg

View of waterward side.
